*Coquet River Action Group*

## CRAG – where our groups are testing

## Brinkburn, Swarland and Felton testing sites

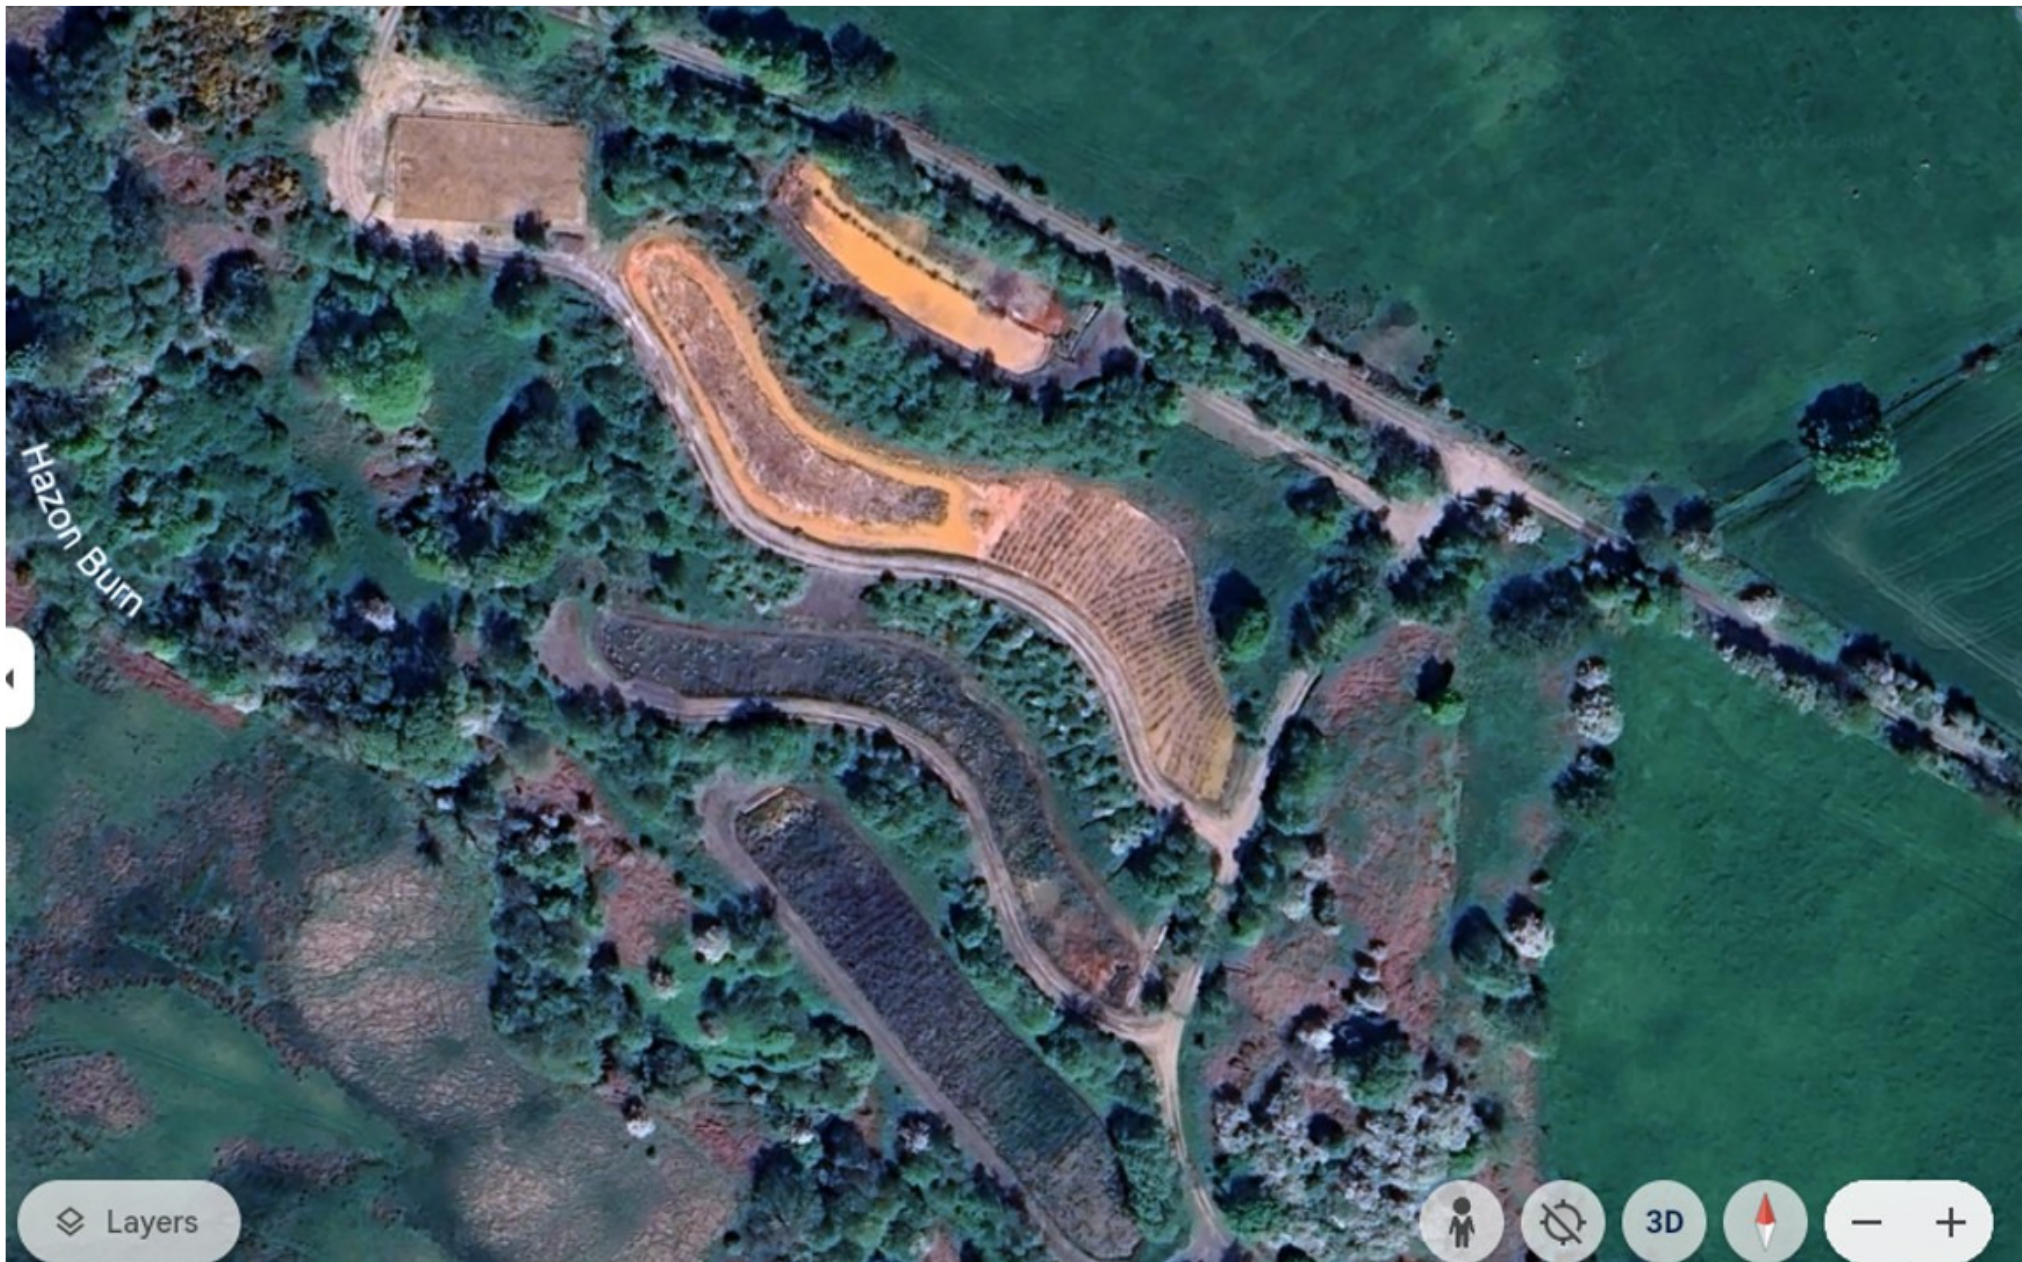
# pH

- Some moderate (pH = 6 - 7) (Hampeth burn)
- In Shilbottle we see low pH from mine outflow. But not so on Hazon burn.
